Train Crashworthiness

Test involved 35-mph impact of car into rigid wall

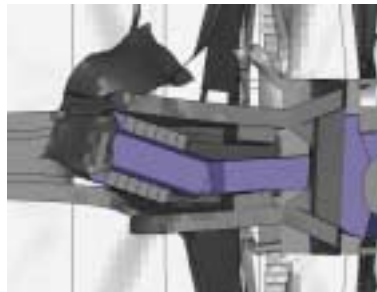
High-Speed Photograph

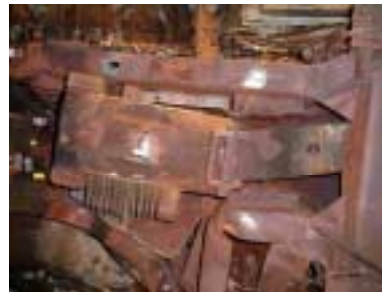
Calculated Sill Collapse
